# CHISANA

## HISTORIC STRUCTURE REPORT

THE U.S. COMMISSIONER'S COURT,  
THE U.S. COMMISSIONER'S RESIDENCE, AND THE WOMEN'S JAIL  
CHISANA HISTORIC DISTRICT  
WRANGELL-ST. ELIAS NATIONAL PARK & PRESERVE  
ALASKA

PREPARED BY  
CRAIG W. DAVIS, REGIONAL ARCHEOLOGIST  
DAVID E. SNOW, REGIONAL HISTORICAL ARCHITECT  
ROBERT L. S. SPUDE, REGIONAL HISTORIAN

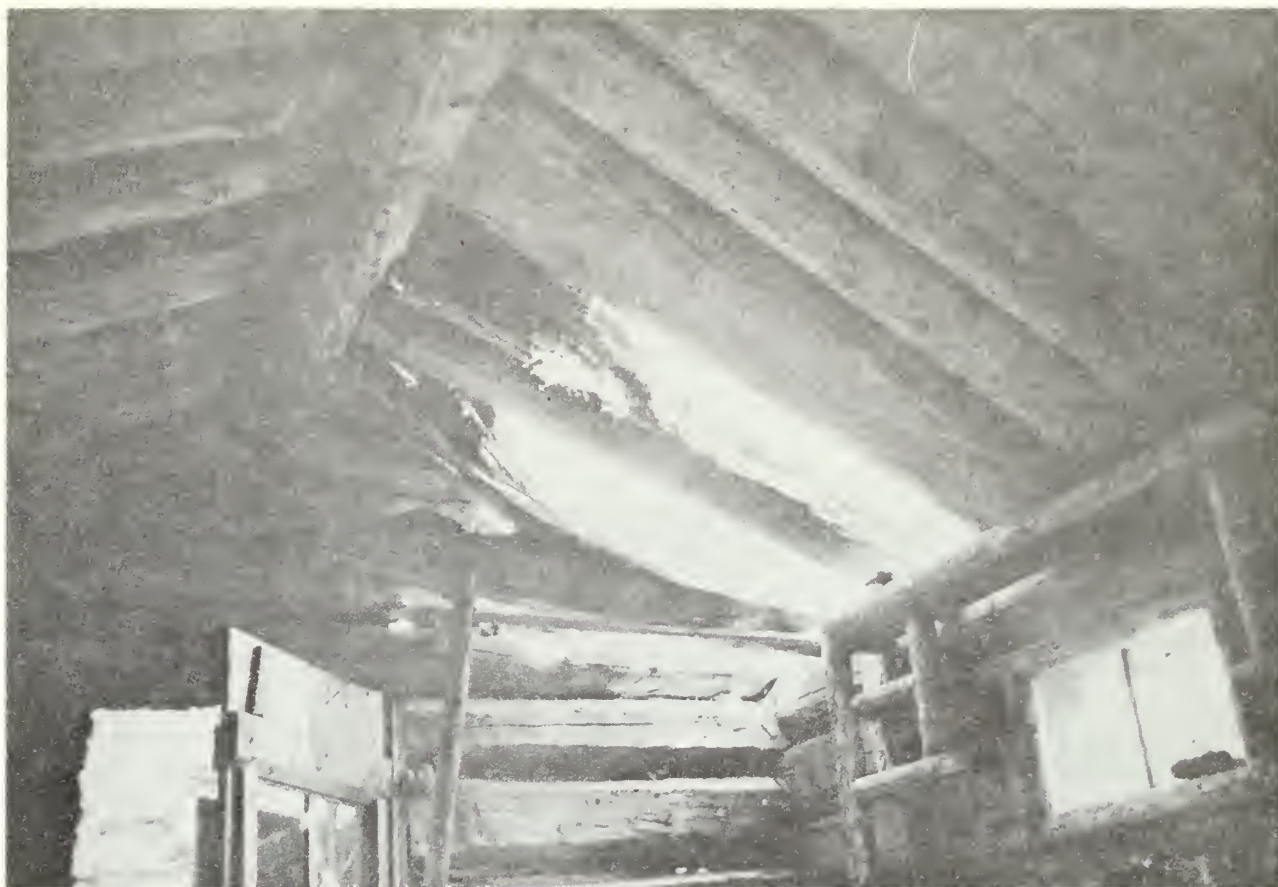
The window on the west end appears to have been a later addition. It is a different style from the north and south windows and is potentially large enough to crawl out of (not very efficient in a jail). The frame is loose, all boards are weathered and the stops are missing as is the glazing. The shelf above the window is in good shape.

Photograph 8  
Women's Jail, Chisana  
Interior; West wall, shelf & window.

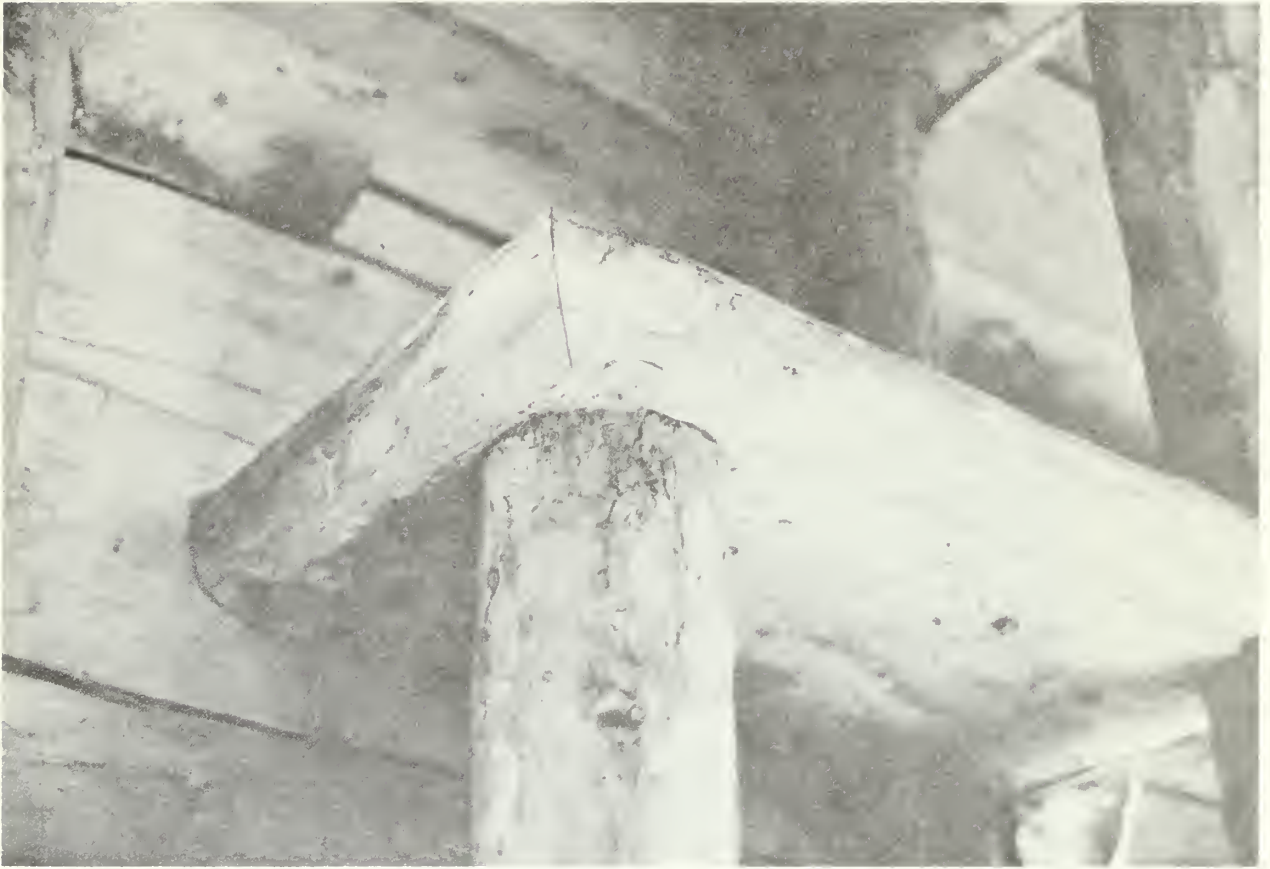
Photograph 11  
Women's Jail, Chisana  
Interior; Shelf detail, south wall.

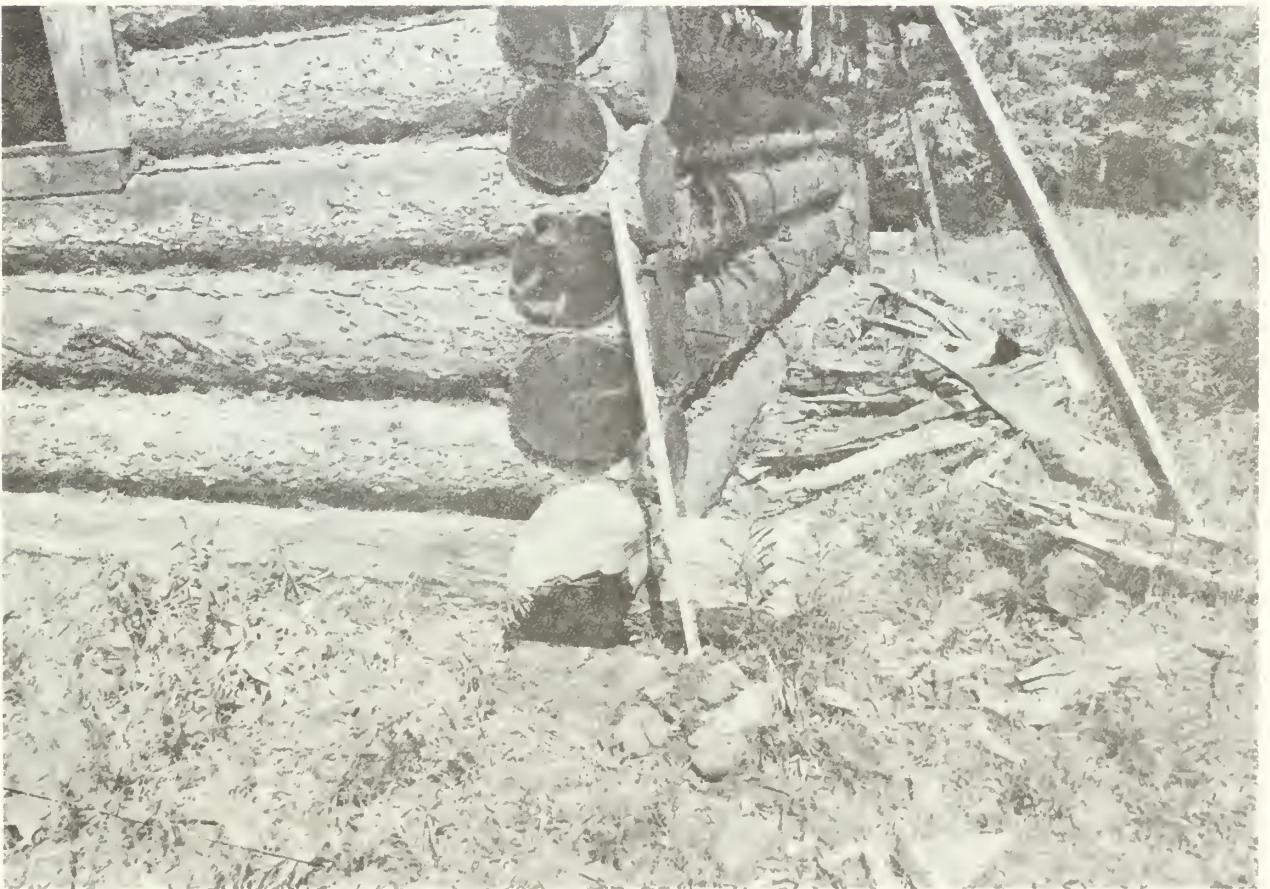
Photograph 12  
Women's Jail, Chisana  
Northwest corner, log connections.

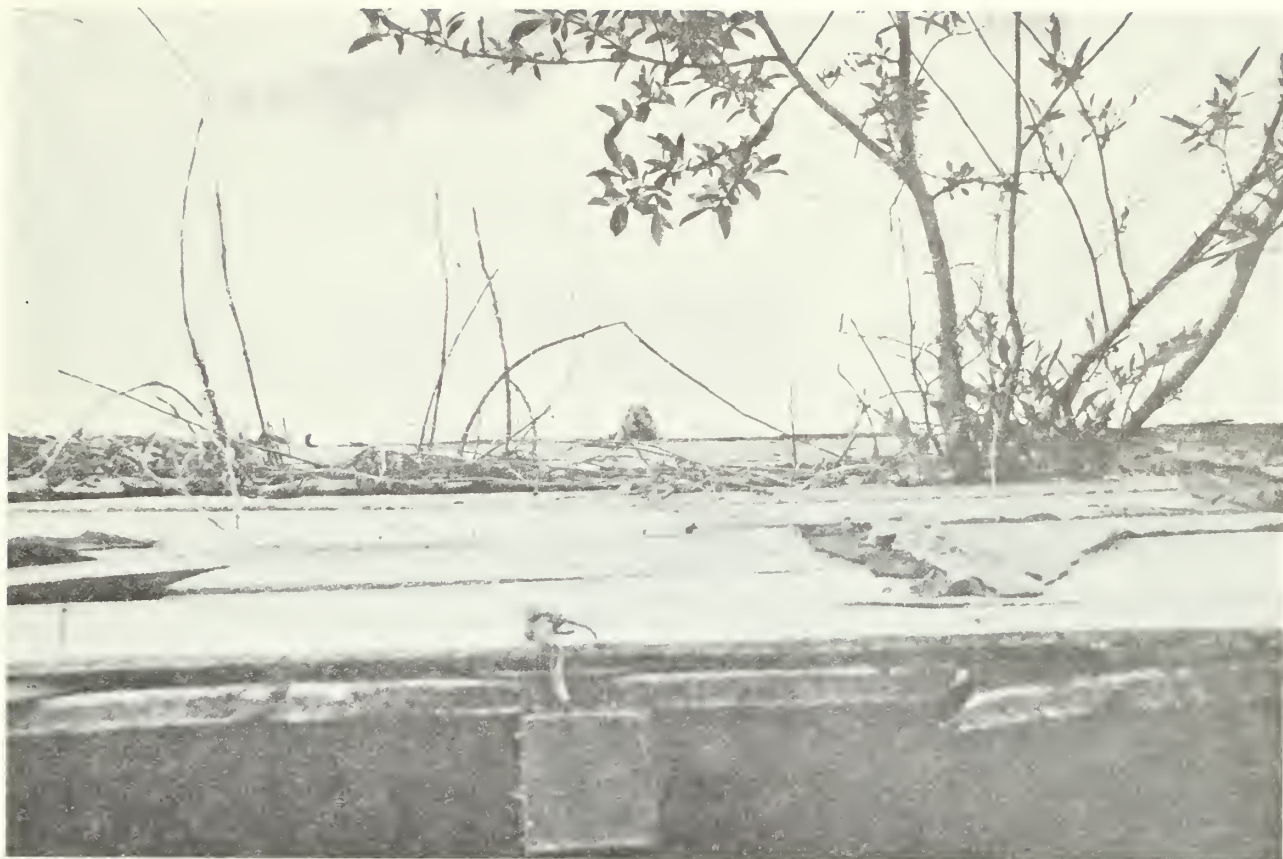
Photograph 34  
U.S. Commissioner's Residence, Chisana  
Roof detail with vegetation and  
present occupant.

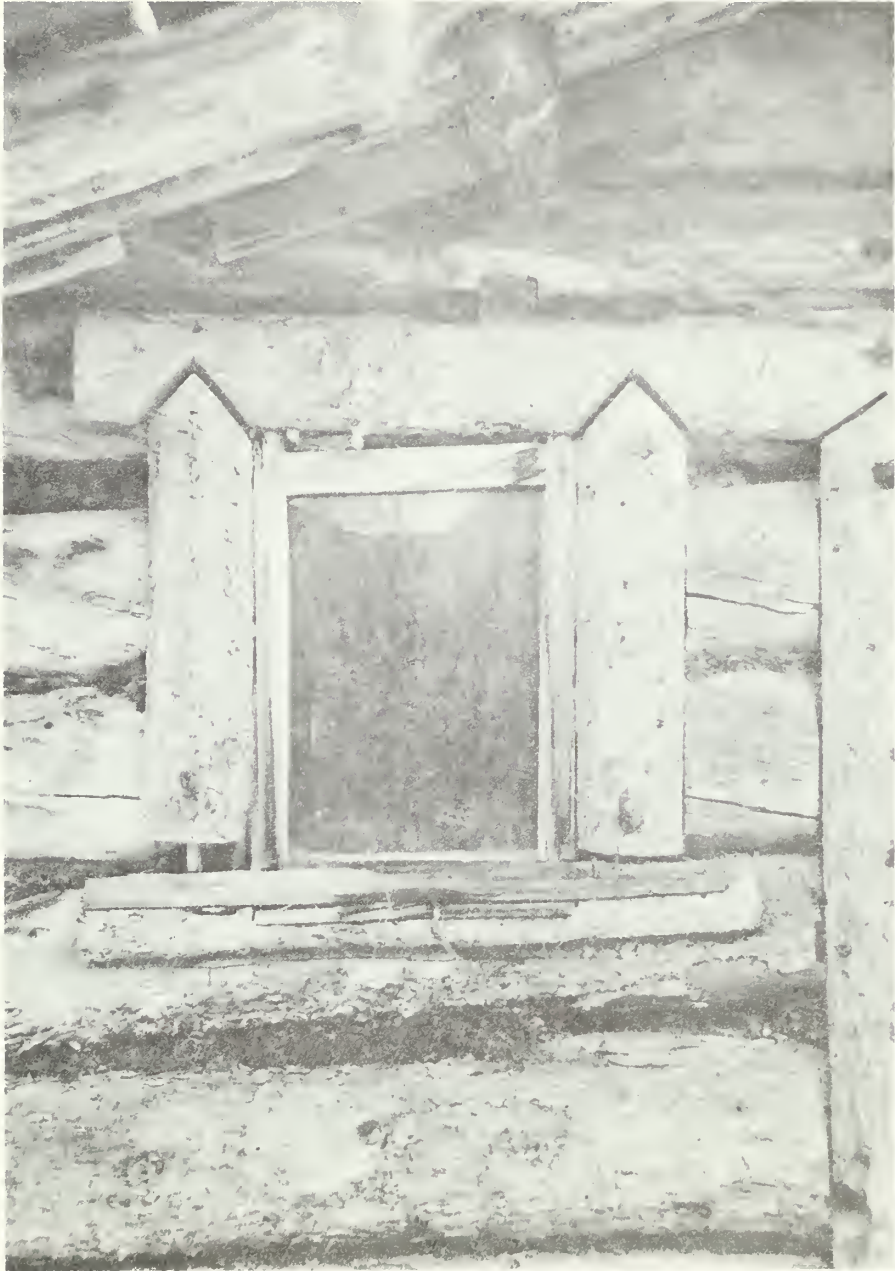
Front window with racked frame and  
seperating trim (note pegs nolding trim  
in place).

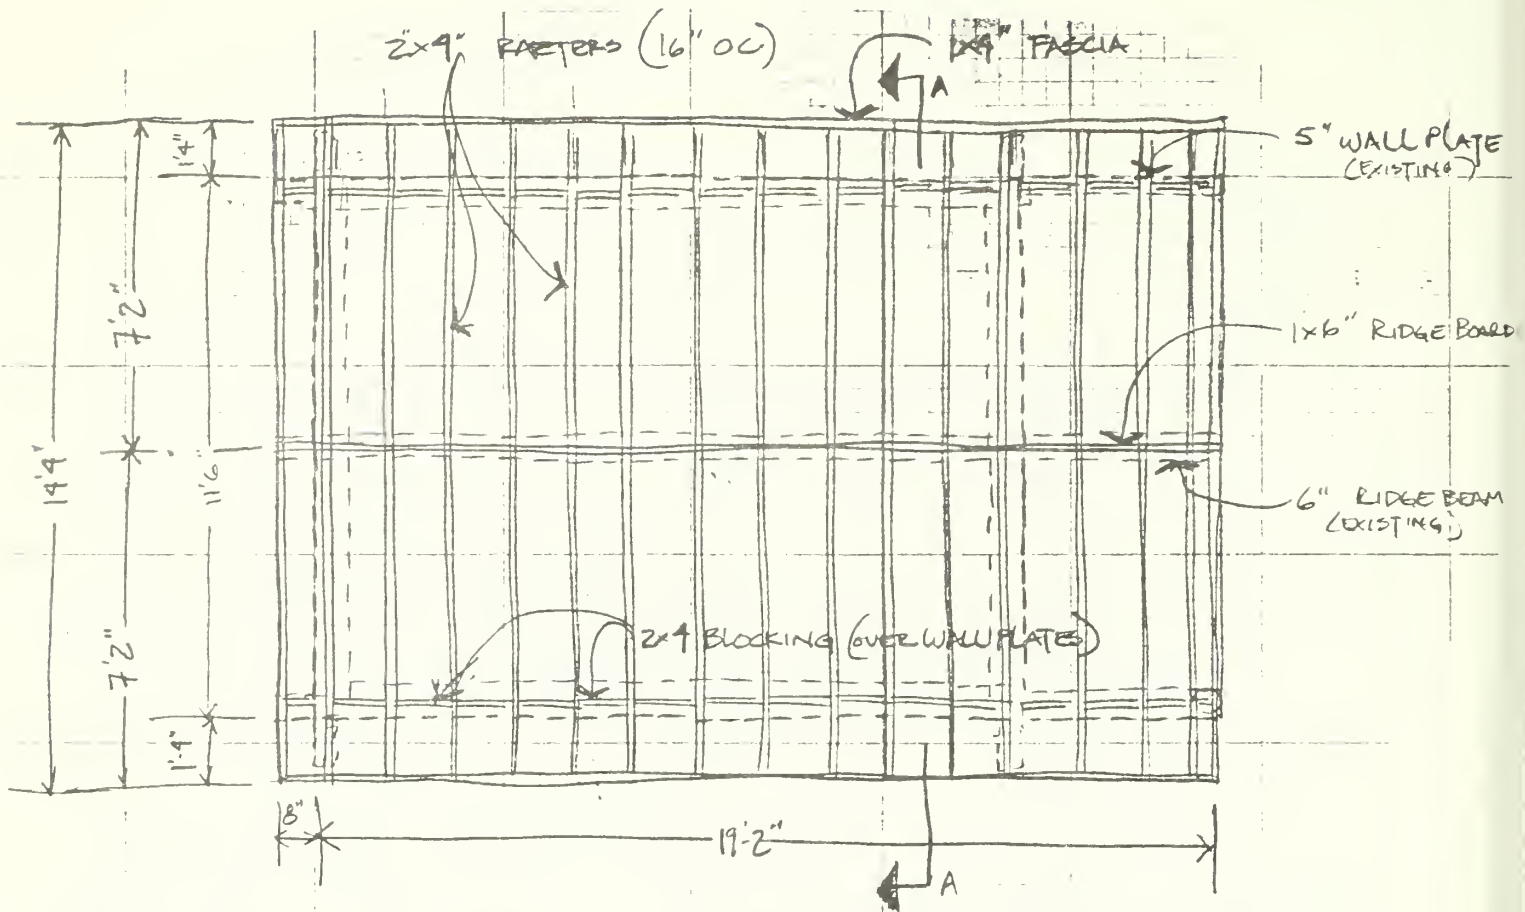
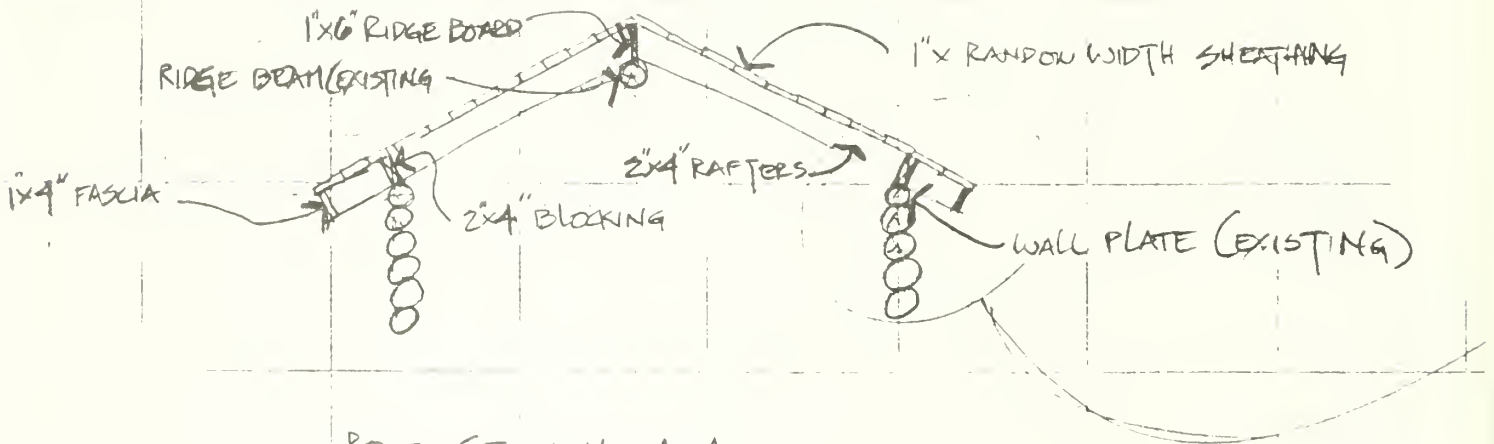
### ROOF PLAN

BAD - CONSIDERABLE ROT & DECAY  
ROOFING SLATS DETEIORATED & MISSING IN PLACES.  
LARGE HOLE (4' x 6') ON SOUTH SIDE - CAUSED BY COLLAPSE OF A CEILING MEMBER.  
RIDGE BEAM & WALL PLATES IN GOOD CONDITION  
CEILING MEMBERS GOOD ON UNDERSIDE - ROTTED ON TOP WHERE IN CONTACT WITH SOD INSULATION.  
PORCH CEILING DETEIORATED.

PLACE 1"x4" FASCIA BOARD ALONG CUT ENDS OF RAFTERS (NAIL W/ 3-16d NAILS @ EACH RAFTER).  
30 LB ROOFING FELT UNDER TIN ROOFING.

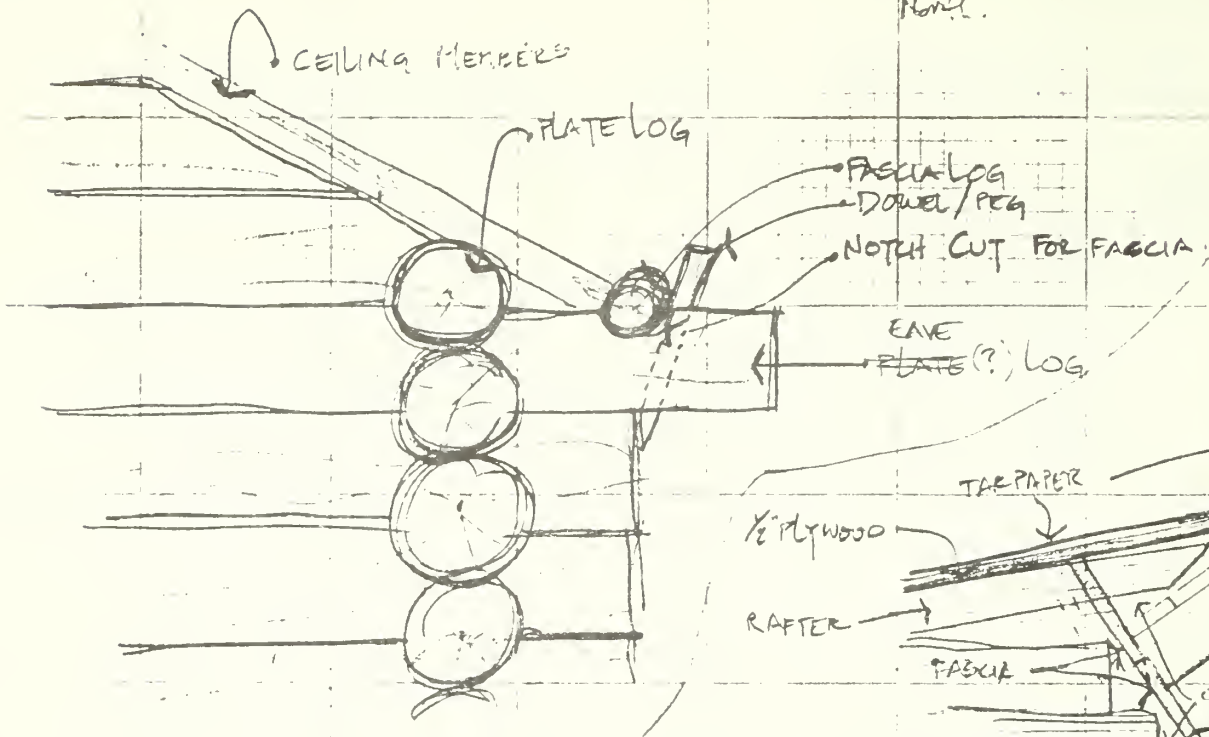
# #1 DETAIL - GABLE END FASCIA

MAIN CABIN WALL IN GOOD SHAPE - BOTTOM LOG  
DECAYING - THE REST INCLUDING PLATE LOG IN GOOD SHAPE  
PROBLEM @ CONNECTION OF ADDITION: CABIN LOGS GROOVED TO  
ACCEPT LOG WALL OF ADDITION. (SEE DETAIL #1)  
PROBLEM WHERE WALL & ROOF MEET ROOF OF CABIN (DETAIL #2)  
MANY OF THE 4 1/2" - 5" LOGS ON THE ADDITION HAVE TWO KEEL GOING  
90% OF THE WAY THROUGH THE LOGS IN MIDDLE OF THE  
WALL - IN - FIND OUT WHAT  
WINDOWS FROM ADDITION MAY HAVE COME FROM MAIN CABIN WHERE  
DOOR IS NOW - CASING SLIGHTLY SPLAYED AT BOTTOM - NOT  
BUILT FOR THE FRAME  
ADDITION LOGS PEELER INSIDE & OUT  
MAIN CABIN LOGS UNPEELED & HEAVY FLAT INSIDE  
MILDEW FORMING ON TOP LOGS OF SOUTH WALL OF ADDITION

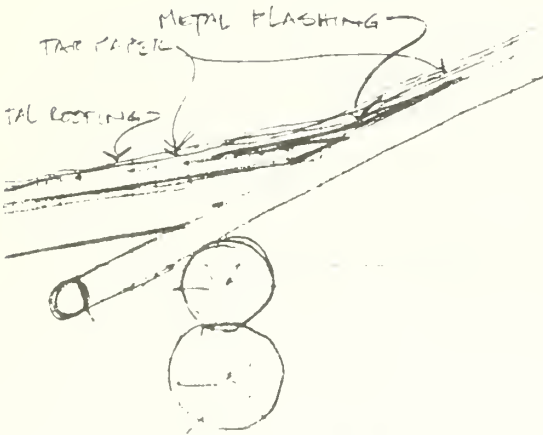
## #2 DETAIL - ADDITION NOT TO SCALE

POOR - SOD ROOF ROTTING TOPS OF CEILING MEMBERS. (9' x 4" to 6" HALF SPLIT WHITE SPRUCE LOGS AND SPLIT SIDE DOWN) (9' 6" ON WEST SIDE)  
 NEWER ROOF ON TOP W/ FELT PAPER - FAIRLY GOOD SHAPE - NO SHEVDS GROWING - LIGHTLY ASYMMETRICAL W/ RIDGE SHIFTED TO EAST. (in front - Symmetrical in back)  
 STRUCTURAL MEMBERS - RIDGE, FURLINS & PLATE LOGS IN GOOD SHAPE  
 "PLATE" LOGS AT GABLE ENDS MISSING SUPPORT NOTCHES FOR ROOF FASCIA BOARD.  
 (SEE DETAIL #2 BELOW LEFT #1)  
 ROOF IN ADDITION - CHANGE IN SLOPE (TO 3:12 MAX FROM 5:12)  
 1/2" PLYWOOD ON 3" RAFTER LOGS 16" OC  
 PLYWOOD DELAMINATING, SAGGING & WATER STAINED.  
 RAFTERS EXPOSED TO MOISTURE - SIGNS OF DECAY - REST ON NEW ROOF @ TOP OF PITCH - SEE DETAIL #2 BELOW LEFT.

REMOVE ALL ROOFING MEMBERS OF NEWER ROOF AND ADDITION ROOF  
 REMOVE SOD & CEILING MEMBERS OF MAIN CABIN  
 SET NEW PLATE LOG SUPPORTS ON GABLE ENDS W/ NOTCHES FOR FASCIA  
 REPLACE CEILING MEMBERS W/ 4" x 6" SPLIT LOGS (W. SPRUCE) SET SPLIT SIDE DOWN - 9' ON EAST SIDE - 9' 6" ON WEST  
 SET NEW 4" RAFTERS ON ADDITION - 16" OC  
 NAIL 1" x RANDOM WIDTH BOARDS ACROSS ADDITION RAFTERS (AS PER DETAIL #3)  
 INSTALL 18" METAL FLASHING AT JUNCTION  
 TIE ROOF OVER BOTH ROOFS  
 METAL SHEET FLASHING (SMALL SHEETS "DESIGNED TO DULL OR PARTIALLY RUST")  
 PLACE 4" x 5" FASCIA LOG ALONG ENDS OF CEILING MEMBERS - SETTING INTO "PLATE" LOGS - DOWEL/PLG INTO POSITION.

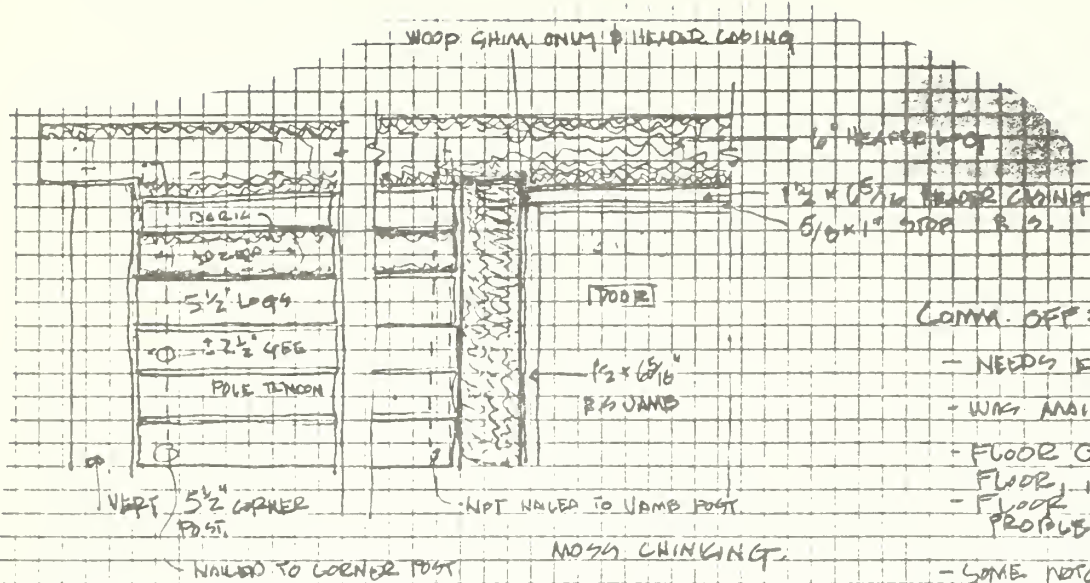
COMM. OFF =

- NEEDS EMERG. ROOF
- WAS MAINTAINED TO 60'S
- FLOOR GOOD, NO EVIDENCE OF FLOOR, WOOD, CEILING COVERINGS
- FLOOR LEVEL = GOOD, SILL LOG PROBABLY NEEDS NEW ONE
- SOME NOTCHES WERE CUT SO THIN THAT LEADS ARE BREAKING OFF
- NEEDS NEW TINT PAPER OR MINERAL PAPER
